2017 Hurricane Harvey Deployment
Arkema Facility Response
8/31/2017 1:45:27 PM

***2017 ASPECT Preliminary Report
Arkema Plant Response
Crosby, TX***

***August 31, 2017
0600 hrs to 1300 hrs***

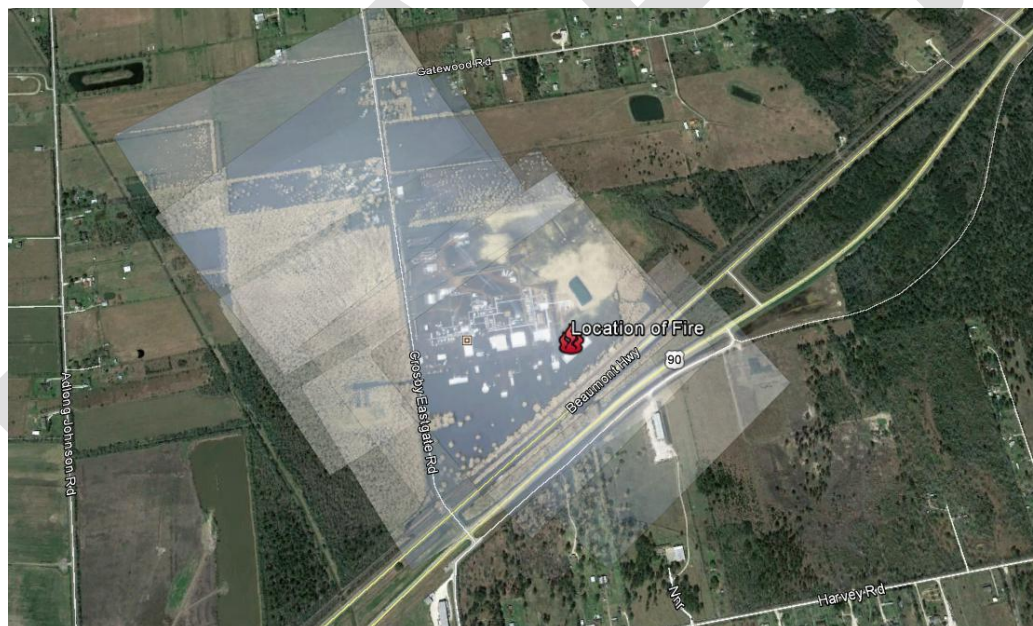
Figures 2 & 3 show a visible image of the facility with no observed plume and the flight path highlighted when IR sensors were active.

Figure 2: Low resolution aerial images pulled from the aircraft while in flight over the facility, 30 August 2017 at about 0730 hrs CST.
